Composite heat damage measurement using the handheld Agilent 4100 ExoScan FTIR

Easy, non-destructive analysis of large parts

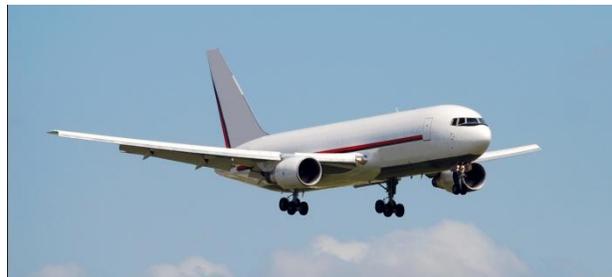
John Seelenbinder
Agilent Technologies,
Connecticut, USA

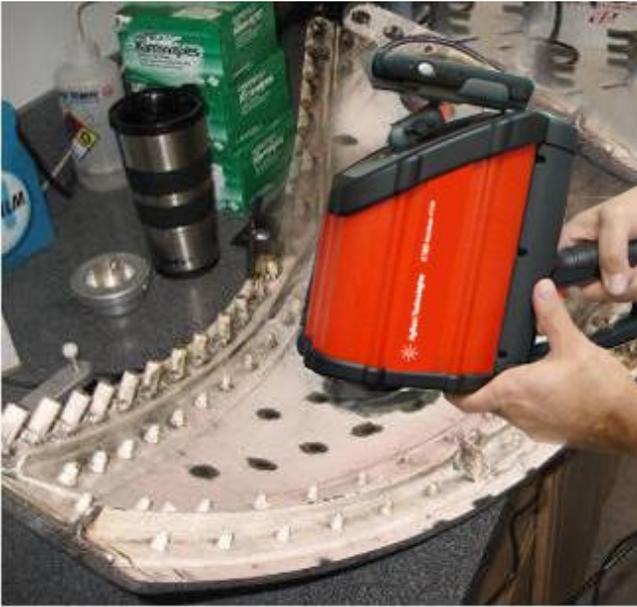
Figure 5. A 4100 ExoScan FTIR being used to measure heat damage on a composite aircraft part, which had been damaged by an engine fire
